Exhibit 1  
Docket No. CWA-309(a)-09-002

U.S. ENVIRONMENTAL PROTECTION AGENCY - REGION IX  
WATER MANAGEMENT DIVISION  
MSGP STORMWATER COMPLIANCE INSPECTION REPORT

Facility:	U.S. Navy Naval Base Guam
NPDES Permit No.:	GUR05A008
USEPA Representative:	Jeremy Johnstone Senior Environmental Engineer
USN Representatives:	Omar Damian, Environmental Engineering Intern, NAVFAC Marianas EVBL Romeo Ascuncion, DZSP 21 Domingo Cabasao, DZSP 21
Guam EPA Representatives:	Oscar Delfin, Engineer II Maricar Quezon, Engineer II
Date of Inspection:	16 July 2008
Report Prepared by:	Jeremy Johnstone

U.S. ENVIRONMENTAL PROTECTION AGENCY - REGION IX  
WATER MANAGEMENT DIVISION  
CGP STORMWATER COMPLIANCE INSPECTION REPORT

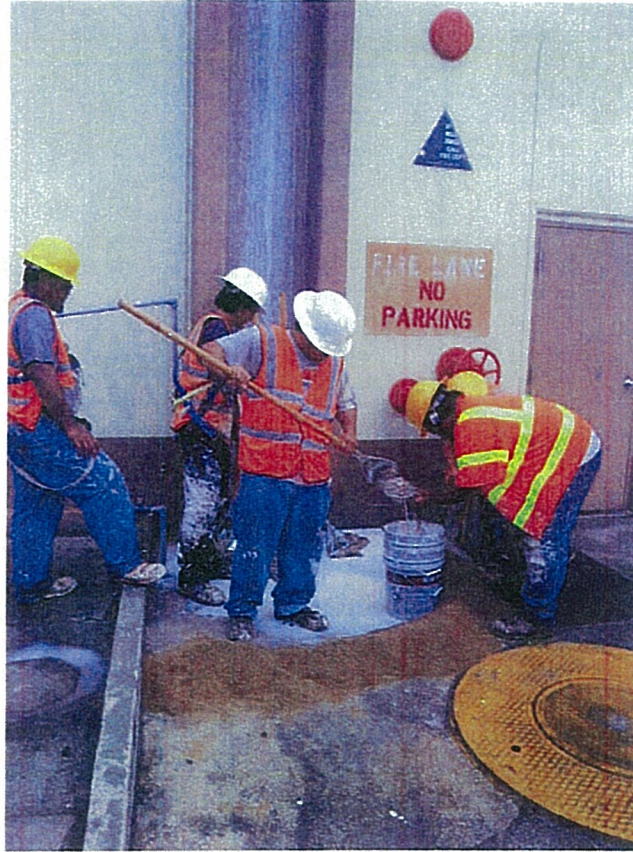
USN Naval Base Guam, MSGP Inspection of Main Base Area, 7/16/08  
IMG\_0006

5. Drive-bys and walkthroughs of select areas of industrial activities indicated that most were clean and well maintained. At the Transportation Maintenance Shop (Bldg 364) a crew was cleaning up wet paint that had been newly applied but washed off of the roof as a result of a rain shower. (Photo IMG\_0006).

- IMG\_0006 Crew cleaning up fresh paint that had washed off of roof in a rain event.
- IMG\_0008 The water in this photo had a visible sheen on it, also asphalt by the fork lifts showed staining from past or current drips and leaks. There were no

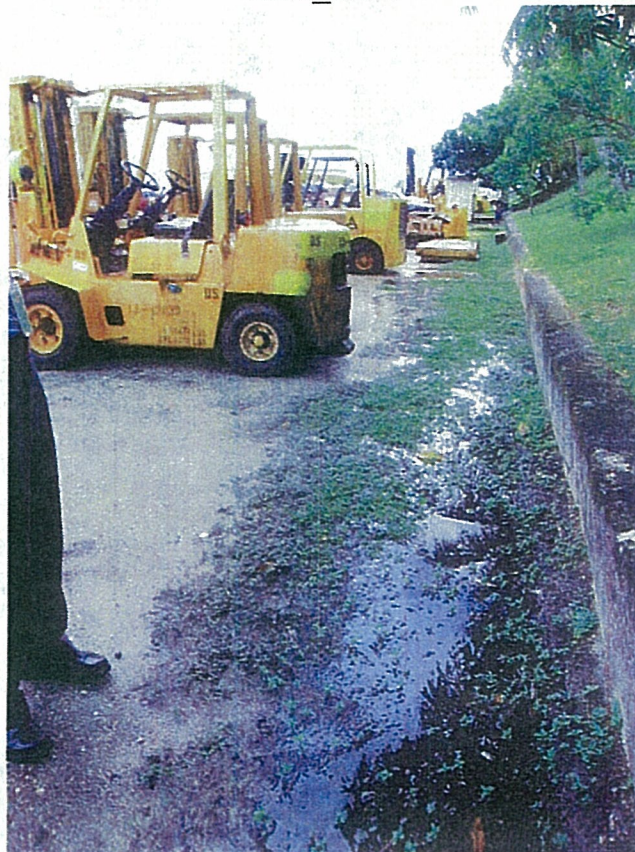
IMG\_0008

6. However, also at the Transportation Maintenance Shop, several vehicles and pieces of equipment were parked over oil stains, some apparently fresh. As there had been a recent rain shower, there was also a noticeable sheen in the area, but there was no evidence of drip pans in use anywhere at this shop. This issue was also noted in the Aug. 2007 ASCE report for this shop, thus it appears to be a chronic issue. (Photos IMG\_0008, IMG\_0009, IMG\_0010).

drip pans or other BMPs in evidence.

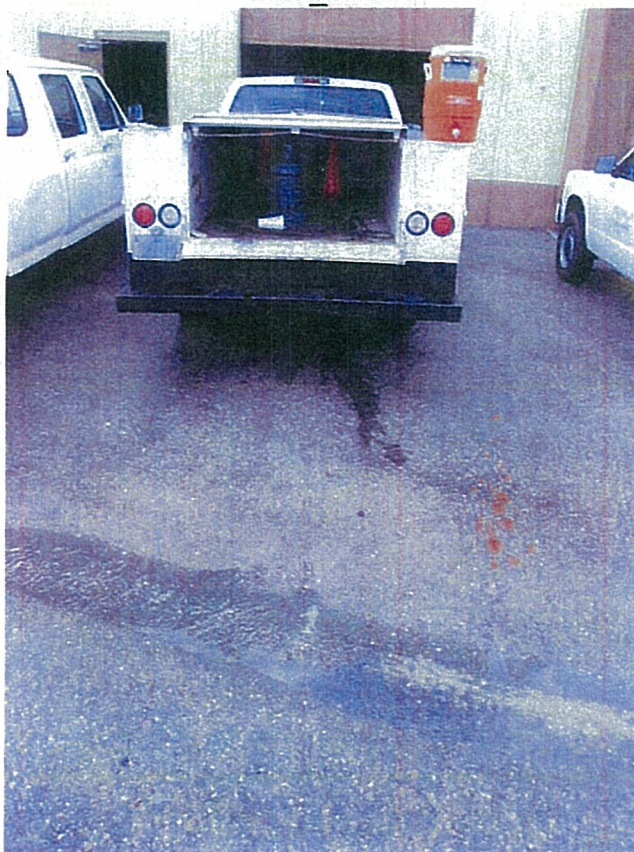
USN Naval Base Guam, MSGP Inspection of Main Base Area, 7/16/08  
IMG\_0009

IMG\_0009 Staining of asphalt, evidence of a drip or leak, under this parked truck, with no drip pan or other BMPs in evidence.

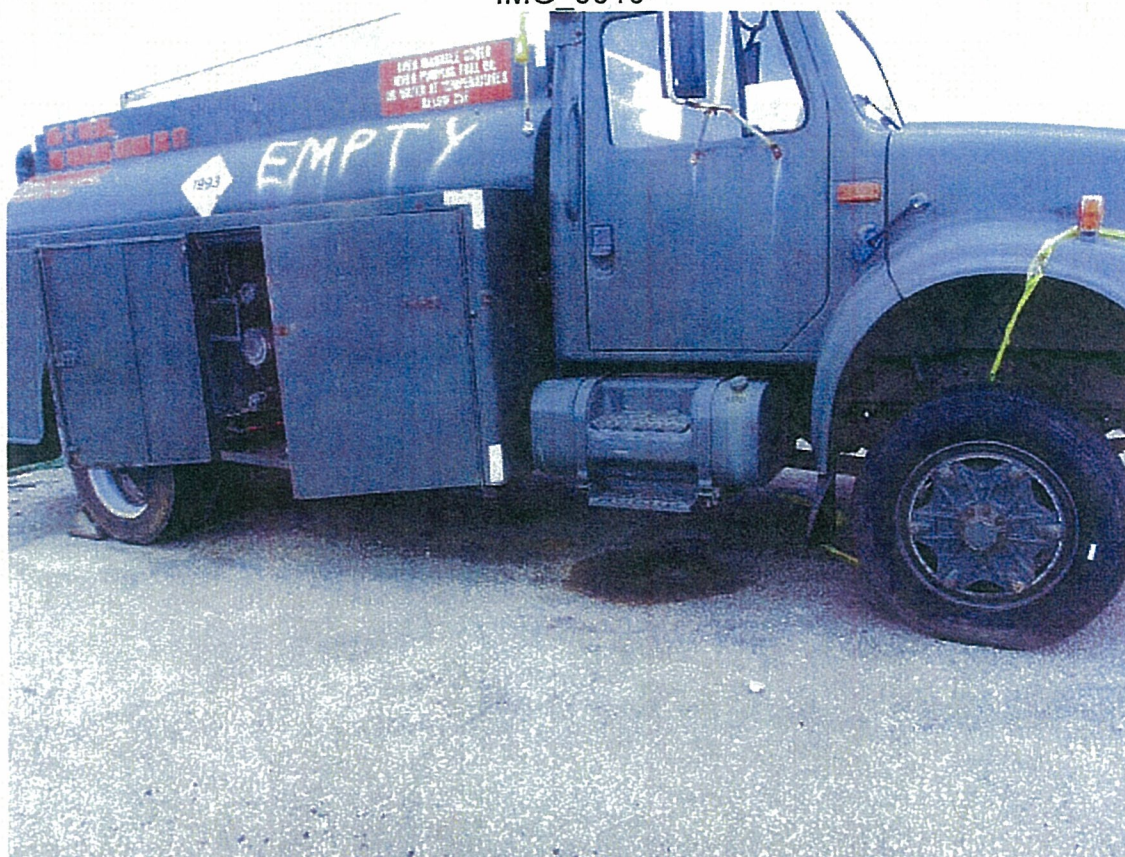
IMG 0010

IMG\_0010 Drip stain under another parked truck, with no drip pan or other BMPs in evidence.

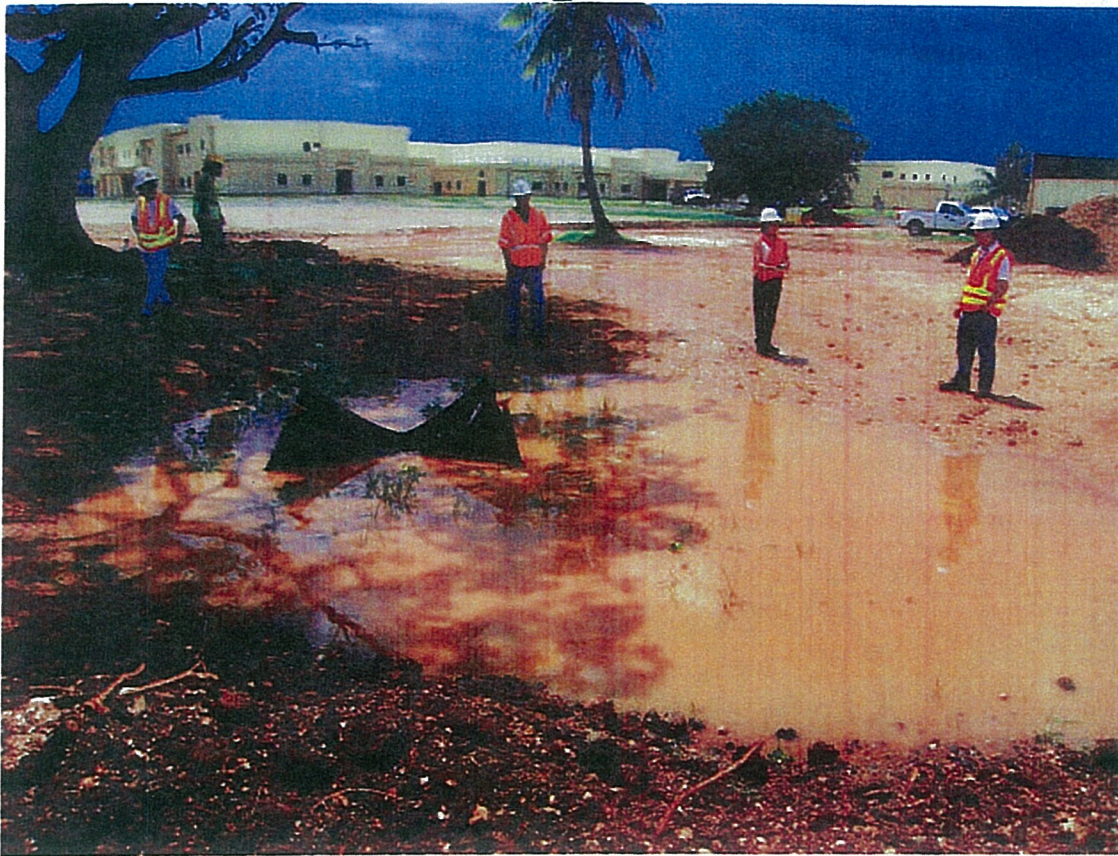
USN Naval Base Guam, CGP Inspection of McCool School Project, 7/16/08  
IMG\_0014

10. The area near to the contractor's trailer office was still being worked, had unstabilized soils and inadequately maintained drain inlet protection BMPs showing evidence of off-site sediment discharges (Photos IMG\_0014, IMG\_0016, IMG\_0017, IMG\_0020).

- IMG\_0014 Ponding basin on east side of school near subcontractors' offices. Note turbidity in standing water and failed silt fence used as inlet protection.
- IMG\_0016 Failed silt fence used as drain inlet protection, project's southwest perimeter.
- IMG\_0017 Unstabilized soils and silt fence used as inlet protection.

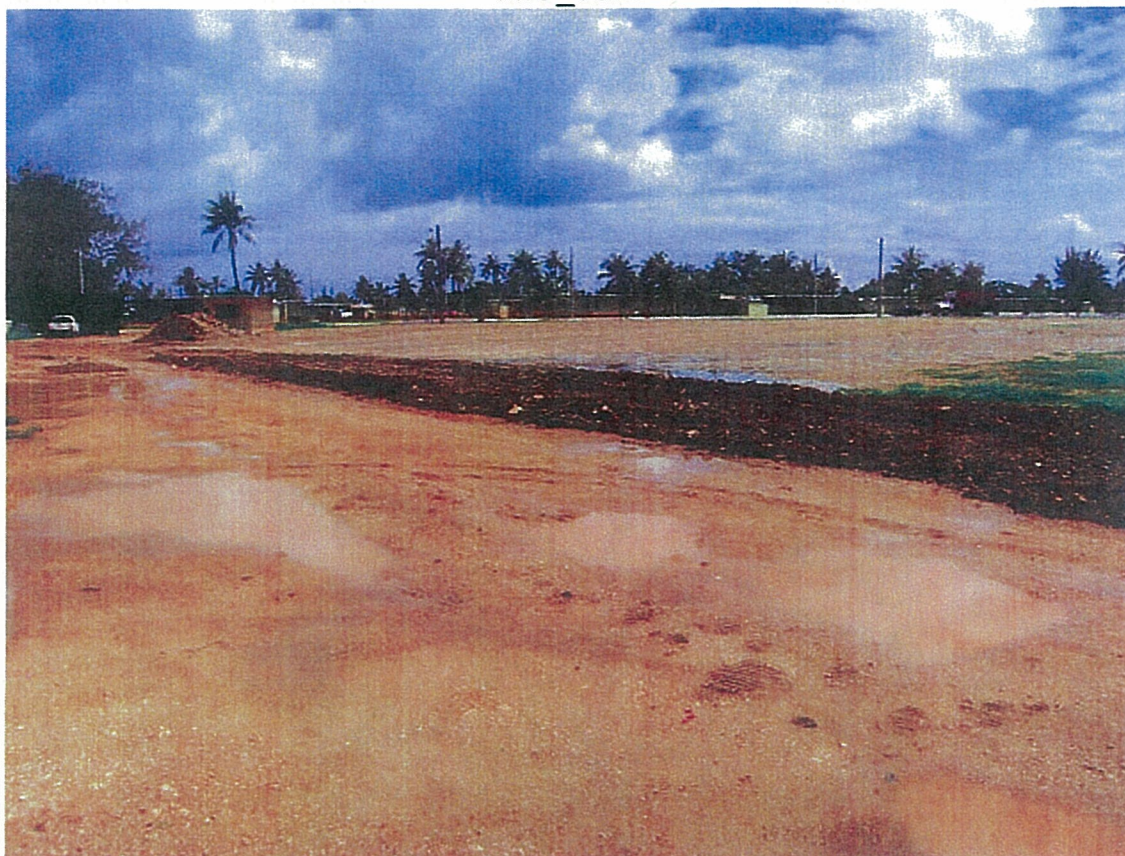
IMG\_0020 Unstabilized soils upgradient of the drain inlet shown in IMG\_0014.

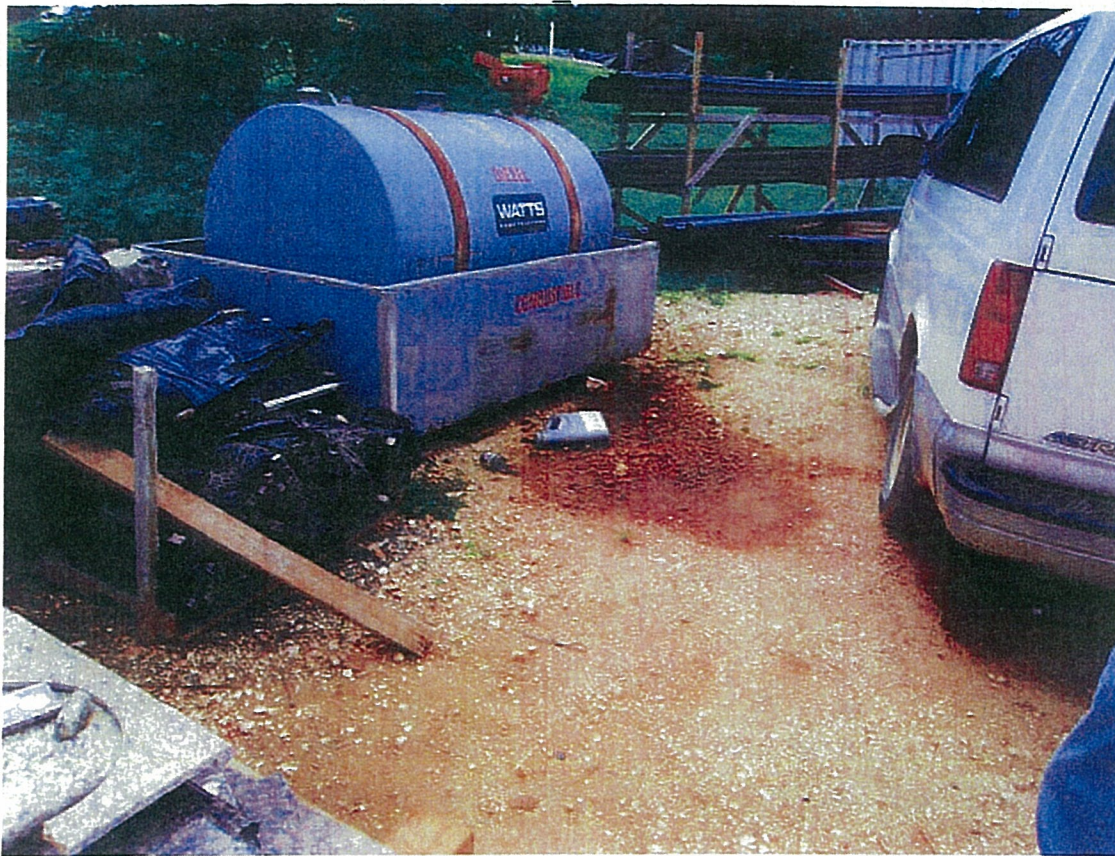
USN Naval Base Guam, CGP Inspection of North Tupalao Housing Project, 7/16/08  
IMG\_0022

IMG\_0022 Stained soil and empty bottle next to a diesel tank

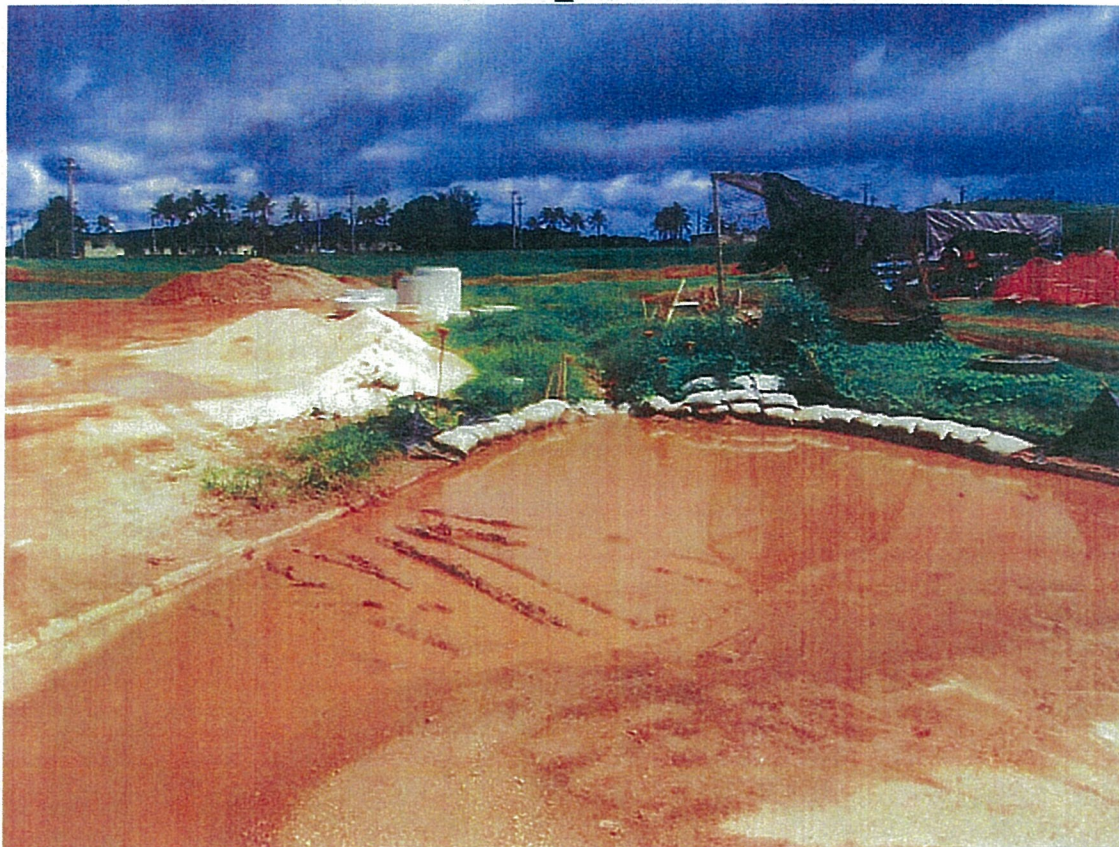
13. The NOI that was submitted on 17 July 2008 indicated Agat Bay as the nearest named receiving water, and also indicated that a SWPPP for the project had been prepared prior to filing. However, no SWPPP was available on-site at the time of the inspection.
14. At the contractor's yard, there was evidence of fluid spillage and staining of the ground, with no clean-up having yet been performed. (Photos IMG\_0022, IMG\_0023)
15. There were few or no soil stabilization BMPs employed within the project, resulting in sediment transport onto roadways and into drainage systems. (Photo IMG\_0034)
16. Drain inlets (DIs) and perimeter sediment controls were inadequately implemented and maintained. (Photos IMG\_0026, IMG\_0035, IMG\_0036)

IMG\_0026 Ponded water where runoff leaves the project area at bottom of road by athletic fields. Note gap in gravel bag berm, turbid water, lack of BMPs by stockpiles to left.

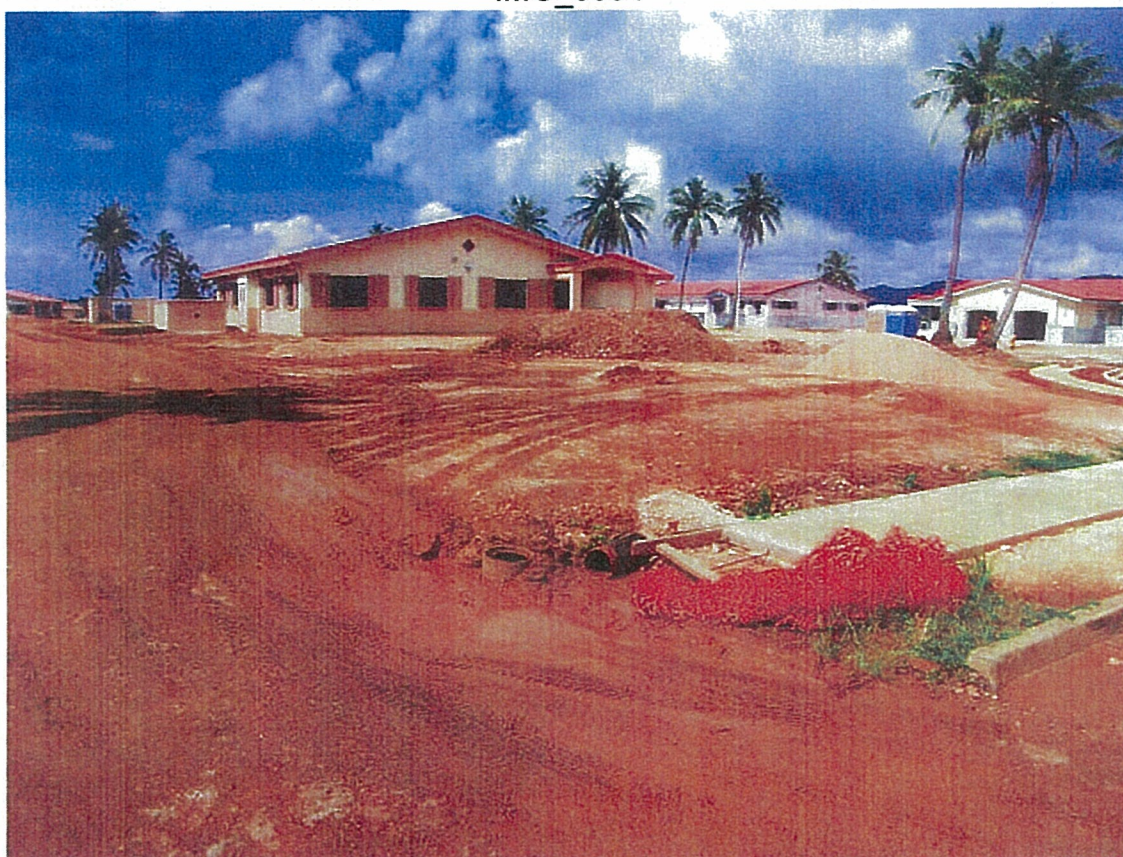
IMG\_0034 Landscaping activities at Phase 1 area. Note unstabilized soils, lack of any BMPs, and heavy sediment accumulations in roadway.

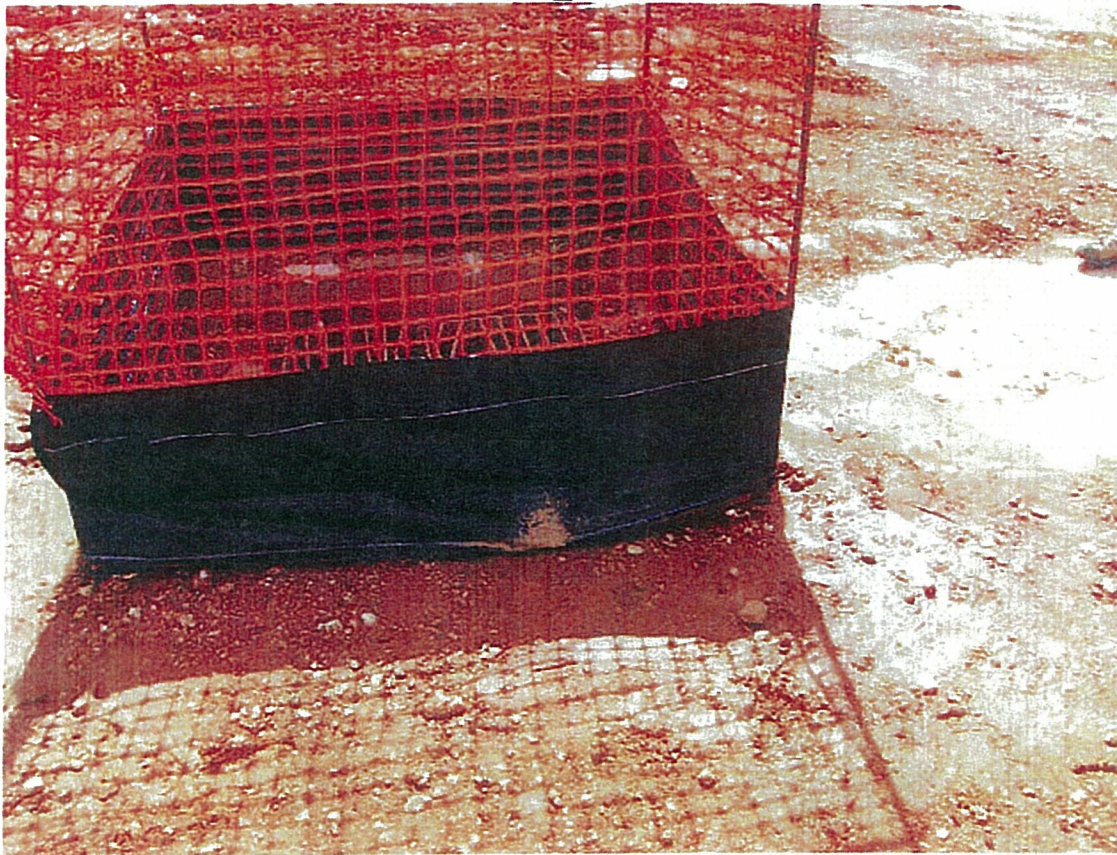
IMG\_0035 Silt fence used as drain inlet protection. Note gap beneath, unstabilized soils upgradient, and sediment accumulations in roadway.

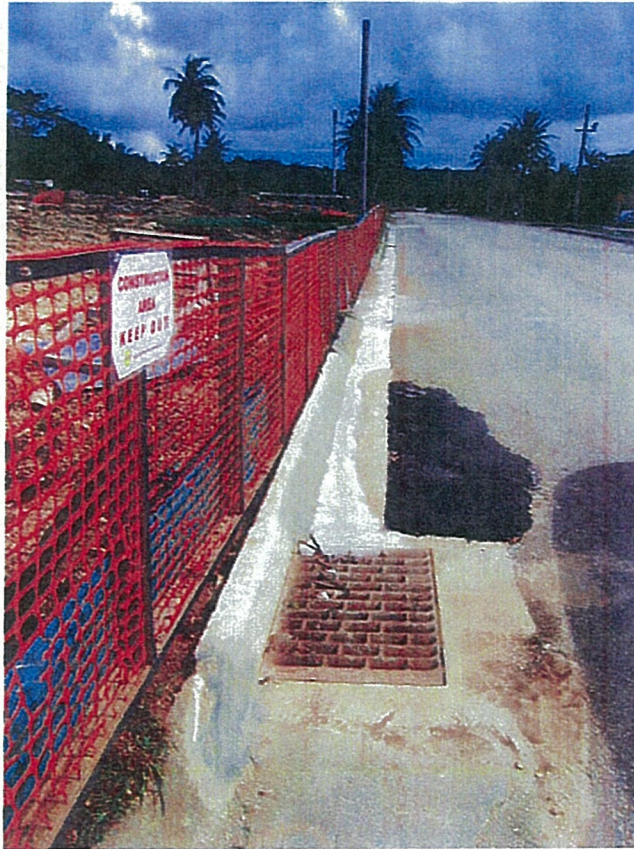
USN Naval Base Guam, CGP Inspection of Apra Hieghts Housing Project, 7/17/08  
IMG\_0022

17. This project to revitalize a typhoon-damaged housing complex was viewed only from the public street at the lower end of the project perimeter.
18. The project's general contractor, Black Construction, submitted an NOI seeking coverage under the CGP on 18 October 2007. EPA assigned tracking No. GUR10A090 to the project and granted permit coverage effective 25 October 2007. The NOI indicated a DSA of 62 acres and the Aplacho River was listed as the nearest named receiving water.
19. Viewed from the bottom of the project are, no internal controls were in evidence and installed sediment controls were inadequate in that sediment accumulations were observed immediately adjacent to a DI. There was also evidence of an apparent concrete slurry discharge off site and to this same DI. (Photos IMG\_0022, IMG\_0023)

IMG\_0022 View along gutter tributary to a drain inlet. Note sediment accumulations and dried concrete slurry.

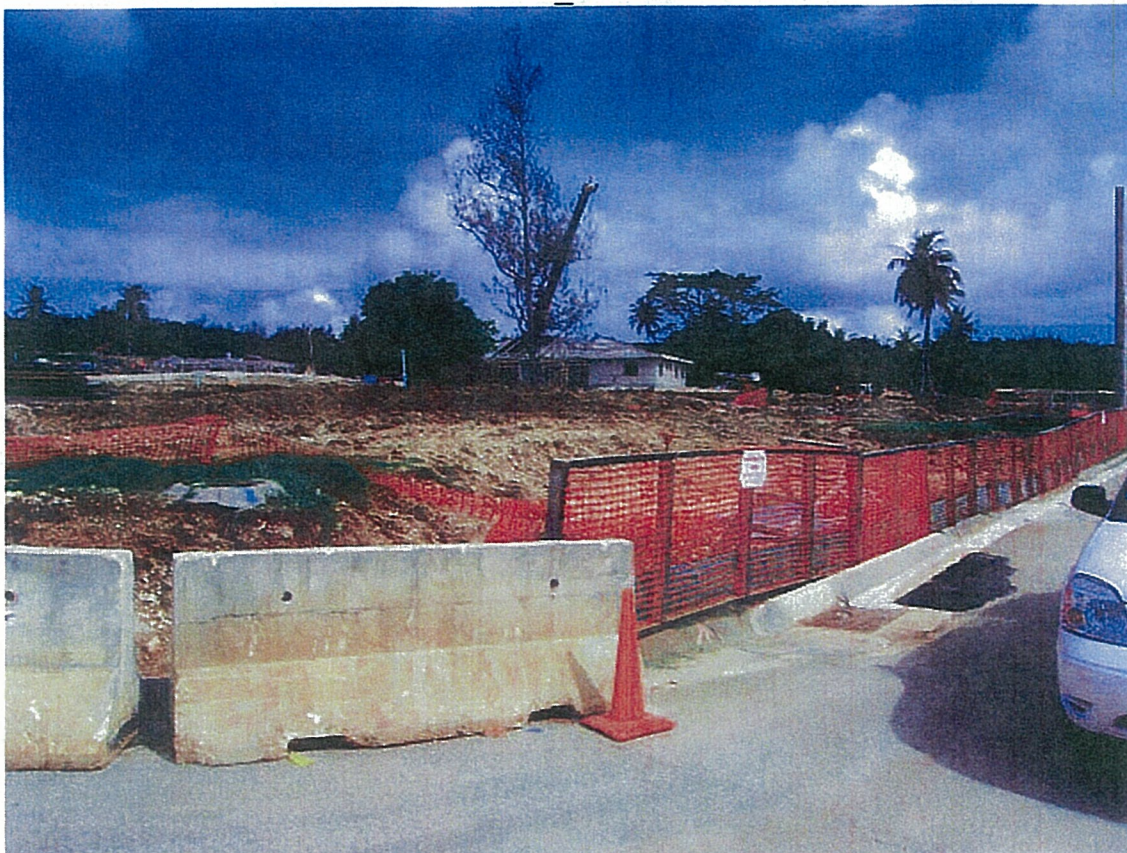
IMG\_0023 Another view of the drain inlet depicted immediately above, note lack of soil stabilization BMPs.
